10 009

FAILURES IN WIRE BASKETS OF URETERAL STONE DISLODGERS

B. W. Christ

Bureau of Medicine/OMR
Food and Drug Administration
Dept. of Health, Education, & Welfare

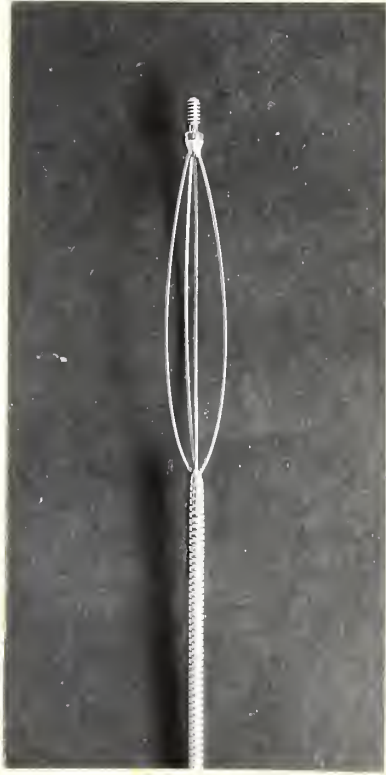
Twelve Ureteral Stone Dislodgers were submitted under Reference 1 for identifying cause(s) of failure. This item is used by the medical profession for removing kidney stones. The features of a stone dislodger relevant to the purpose of this report appear in Figure 1a. This portion of a stone dislodger consists of:

IX
(a) Unused stone dislodger, showing a portion of the flexible cable, the connector between flexible cable and basket wires, the basket wires, and the connector between basket wires and filiform tip. (Filiform tip is not shown.) Unit produced by Greenwald Surgical Co. for C. R. Bard, Inc.

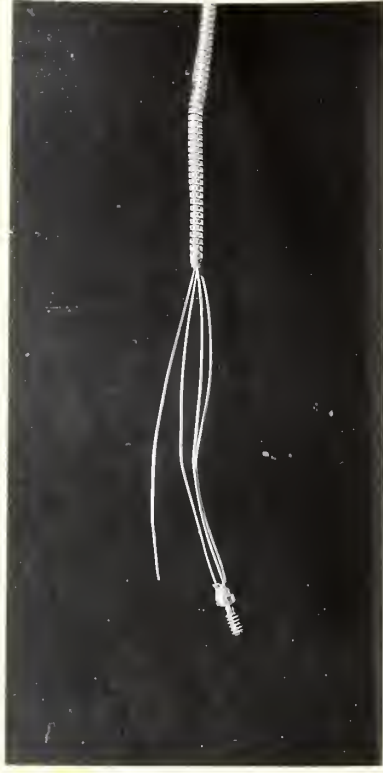
It is reported¹ that the majority of repair items are returned because of basket failure. Typical stone dislodgers which have failed appear in Figures 1b and 1c. One can see that failure in these cases is a matter of the wire basket having come apart near the connectors. Other failures related to the plastic filiform tip have also been reported², but these will not be discussed in this report. The purpose of this report is to identify possible metallurgical causes of the type of failure appearing in Figures 1b and 1c, and to recommend procedures for minimizing the frequency of such failures.

Evidence presented in the preceding section shows that the cause of the typical wire basket failures shown in Figures 1b and 1c is fracture of individual basket wires, in contrast to the possibility that basket wires are pulling free of the soldered joint. Failure is caused by application of loads beyond the fracture strength of individual wires comprising the basket.

IX
(b) Used stone dislodger which has failed. Unit produced by Greenwald Surgical Co. for C. R. Bard, Inc.

1. Since the analysis presented in this report shows that cumulative damage to basket wires during re-use eventually leads to fracture, the most obvious recommendation to make is to minimize the re-use of individual stone dislodgers. Ideally, a stone dislodger should have its basket wires replaced after a reasonable number of cycles of use. A definition of what represents "a reasonable number of cycles of use" will have to be provided by individuals having a day-to-day familiarity with the use of stone dislodgers.

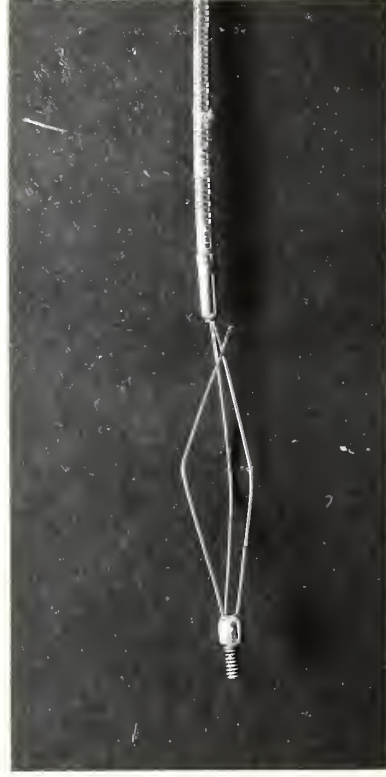
IX
(c) Used stone dislodger which has failed. Unit produced by American Cystoscope Makers, Inc.

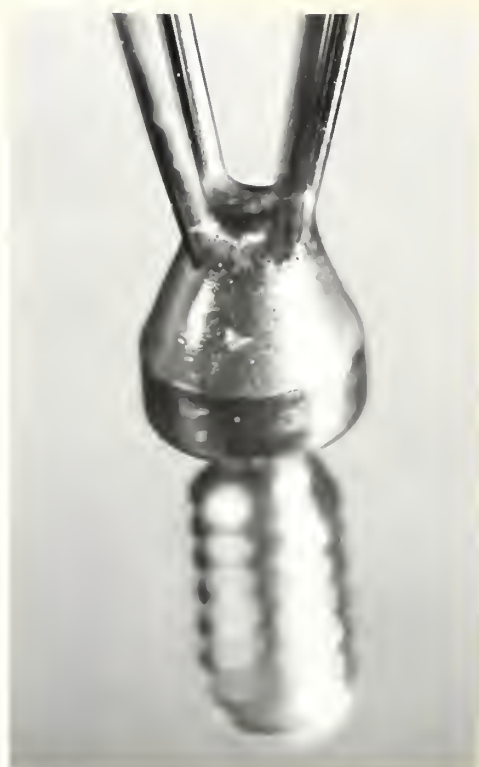
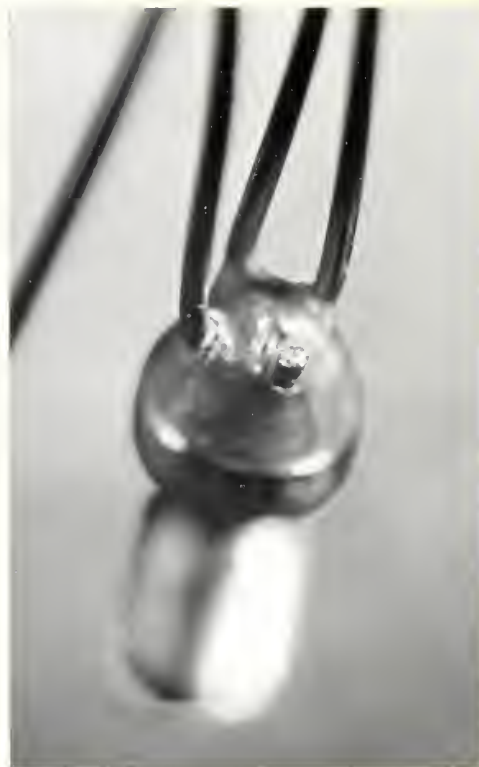
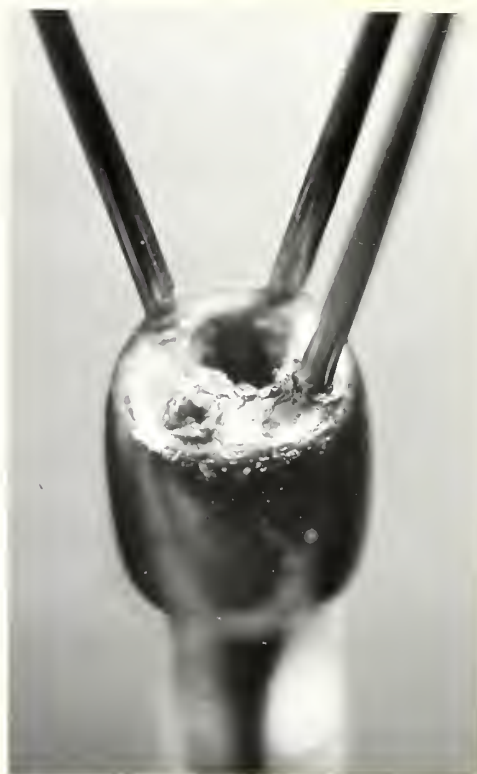
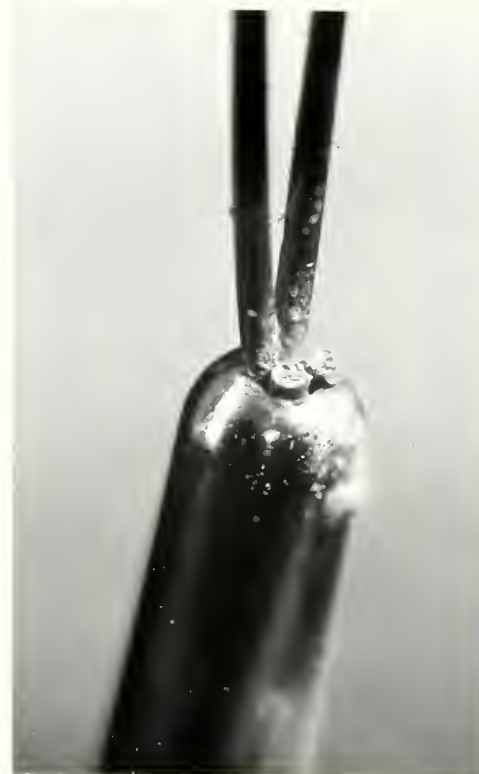
Figure 2. Exterior Views of Soldered Joints.

Examination at magnifications of 10-250 times provides information which serves to identify the possible causes of the typical basket failures appearing in Figures 1b and 1c. For example, Figure 2 shows exterior views at 12X of the soldered joints between basket wires and connectors. Figure 2a shows an intact joint. Figures 2b and 2c show that wires at the filiform connector have fractured. Similarly, Figure 2d shows that wires at the flexible cable connector have fractured. These observations suggest that the cause of wire-basket failure is fracture of the basket wires themselves, and not rupture of the soldered joints.

(a) 12X
Filiform tip end of unused stone
dislodger shown in Figure 1a.

(b) 12X
Filiform tip end of used stone
dislodger shown in Figure 1b.

(c) 12X
Filiform tip end of used stone
dislodger shown in Figure 1c.

(d) 12X
Flexible cable end of used stone
dislodger shown in Figure 1c.

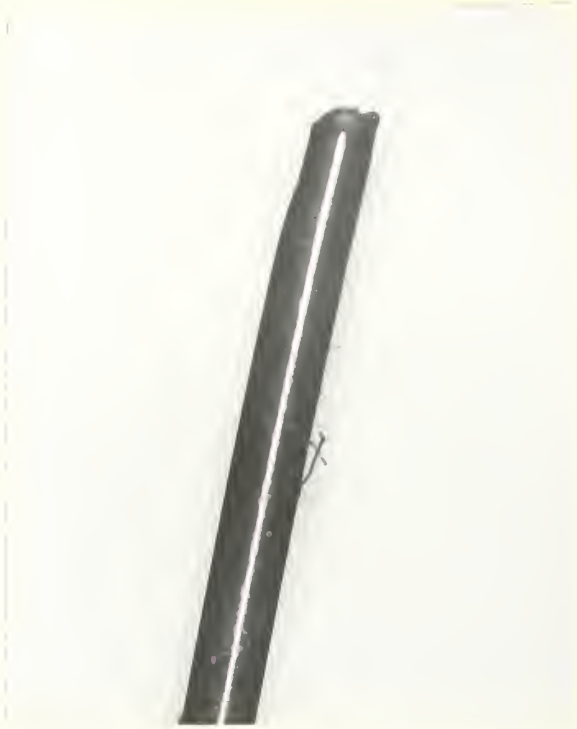
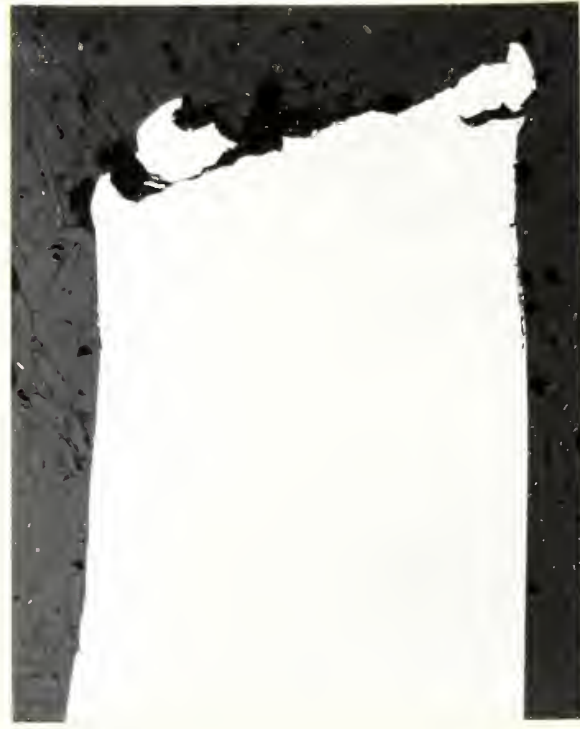
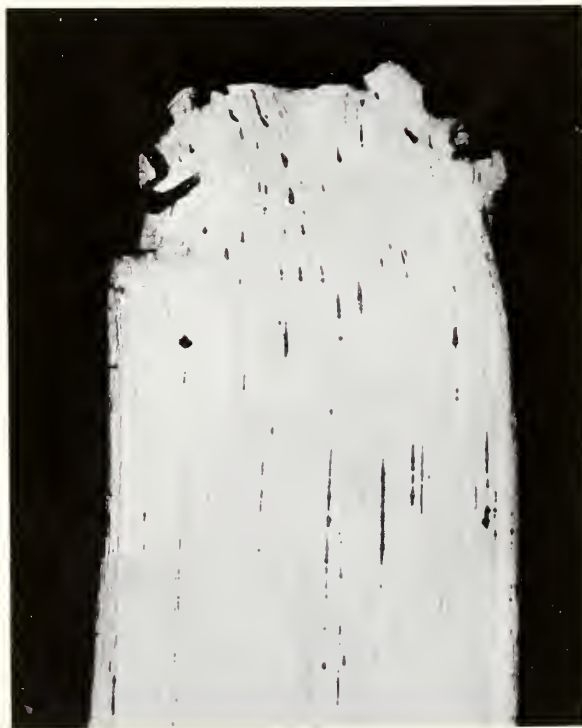
Figure 3. Tip of Fractured Basket Wire Appearing in Figure 1b.

Views of two fractured basket wires appear in Figures 3 and 4. A view at a magnification of 27X appears in Figures 3a and 4a. Close-up views (at 200X magnification) of the fractured tips of these wires are shown in Figures 3b and 4b. These wires have fractured primarily by shear after a small amount of plastic flow. Evidence of a shear failure is the fact that the fracture surface is inclined to the longitudinal axis of the basket wire. Evidence of plastic flow are the shape distortion of the wires themselves and the rounded features of the fracture surface itself. The cracks penetrating the surface of the basket wire shown in Figures 4b originate in the nickel-plated surface layer. The wire shown in Figure 3b does not exhibit such cracks because the wire was not nickel plated.

When sample surfaces such as those appearing in Figures 3b and 4b are etched with 20% HCl-5% HNO₃, features of the metallurgical structure are revealed. For example, after etching, two failed basket wires appear as in Figures 3c and 4c. The layer of nickel plate and its associated microcracks show up clearly in Figure 4c. It can also be seen in Figure 4c that the microcracks are not restricted to the nickel layer; the microcracks actually propagate into the basket wire itself.

Both Figures 3c and 4c show a typical structure for "spring temper" material, i.e., a fibrous appearance with the fiber direction parallel to the longitudinal axis of the wire. For comparison with Figures 3c and 4c, the fibrous appearance of a basket wire from an unused stone dislodger appears in Figure 5. Shape distortion is also apparent in Figures 3c and 4c. These further observations support the viewpoint that the cause of wire-basket failure is fracture of the basket wires themselves, and not rupture of the soldered joints.

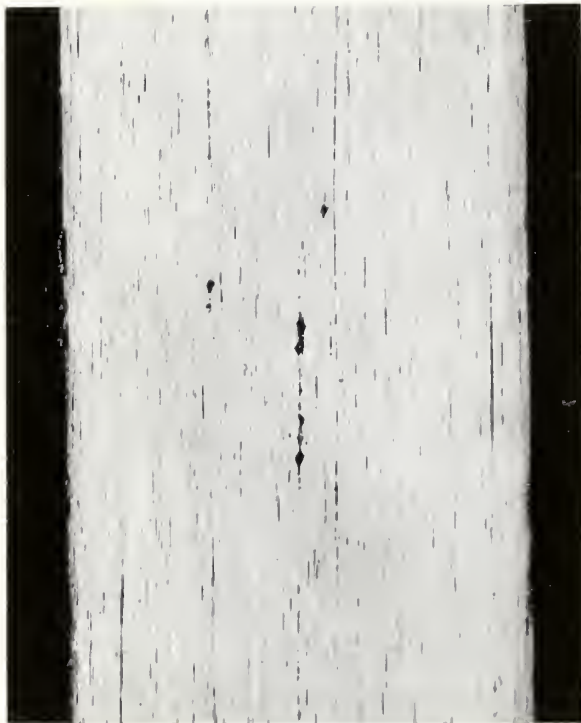
Figure 5. Fibrous appearance of basket wire in spring temper condition. Sample taken from unused stone dislodger appearing in Figure 1a. Etched in 20% HCl, 5% HNO₃.

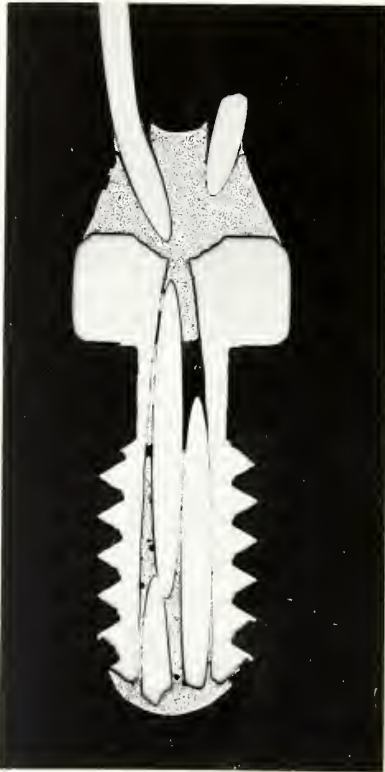
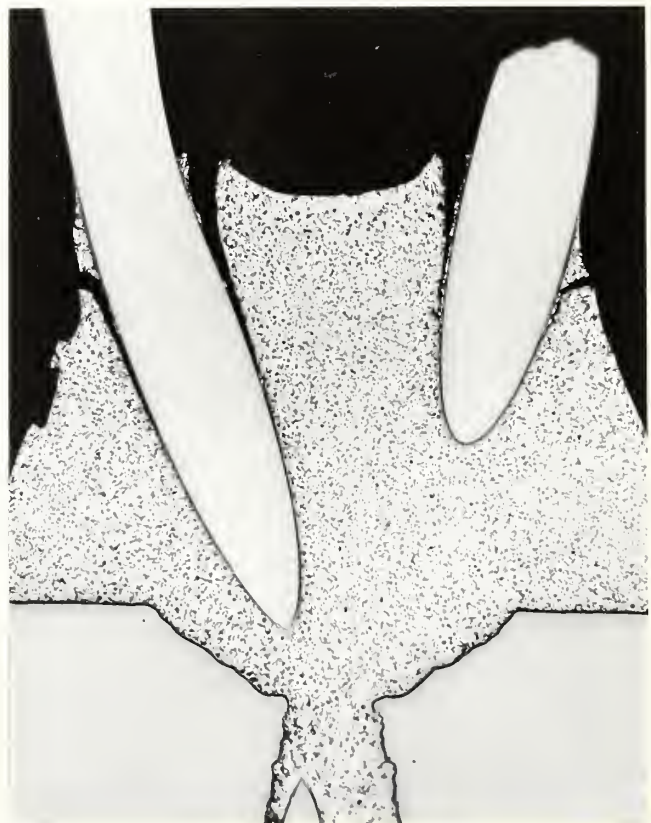
The used stone dislodger shown in Figure 7 shows the features pointed out in Figure 6. In addition, it shows some separation between the basket wire and the bead of solder on the surface of the filiform tip. The extent of this separation is likely to increase with increased frequency of use of the stone dislodger. The significant point to note in Figure 7, however, is that the basket wire fractured before the separation between wire and solder increased to the point where the wire could pull free of the soldered joint.

(7a) 9.5X
Filiform tip and basket
wires.

(7b) 50X
Solder bead appearing in Figure 7a at point where
wires enter filiform tip.

Figure 7. Cross-sectional view of soldered joint within filiform tip. Sample taken from used stone dislodger appearing in Figure 1b.

- b) Bridging of solder within the connector, as in Figures 6a, 7a and 8a, should be minimized by applying sufficient flux and heat during the soldering operation.

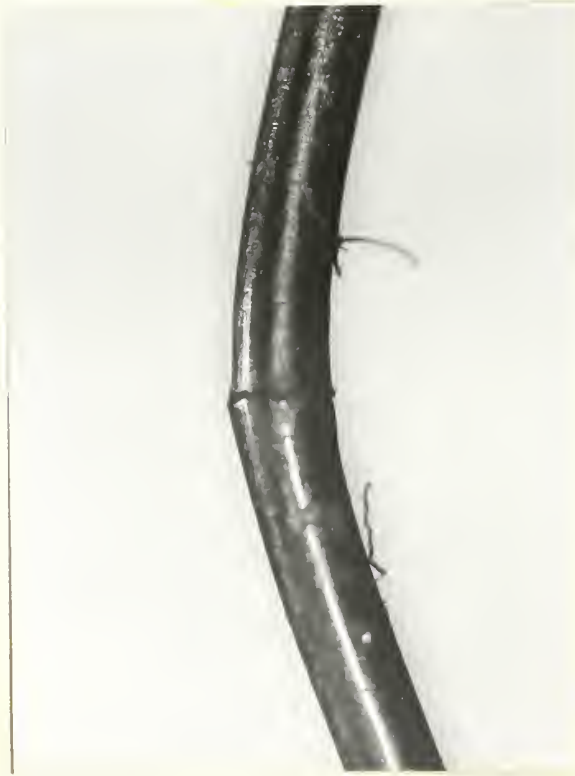
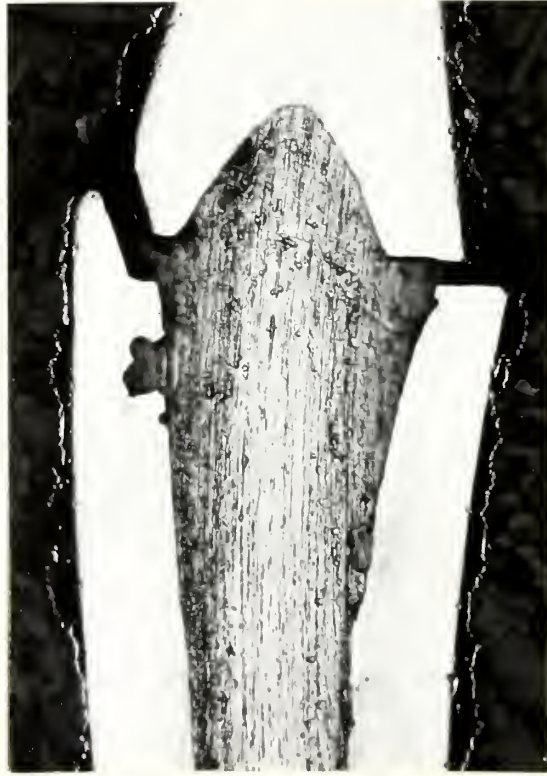
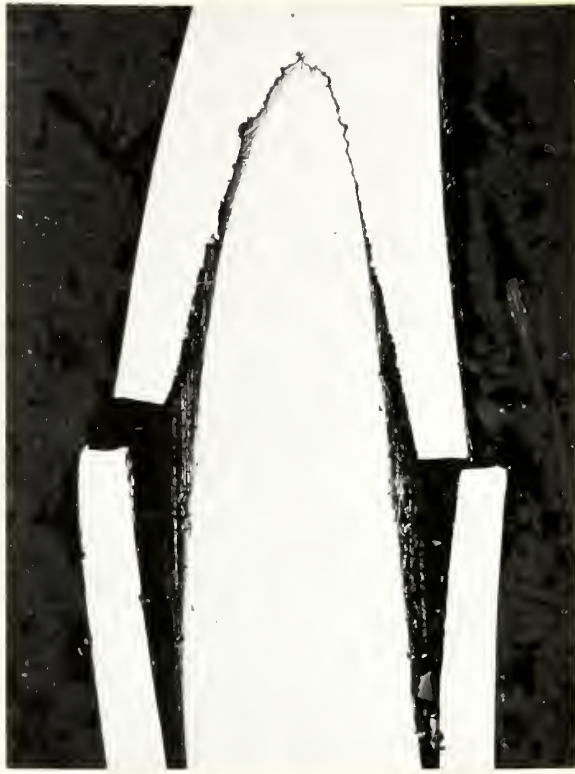
Figure 10. Views of Bent Basket Wire Appearing in Figure 1c.

Longitudinal views of a used basket wire with its nickel plate flaking off appear in Figure 10. These views are close-ups of the sharply bent wire appearing in Figure 1c. Figure 10a reveals a circumferential crack in the nickel layer. (The threads appearing on either side of the crack in Figure 10a are simply dust particles and have no relationship to the crack.) Views of surfaces at the top of the bend in Figure 10a appear in Figures 10b and 10c. Figure 10b is taken at a slightly different section level than that of Figure 10c. Separation of the nickel layer from the basket wire due to poor bonding is obvious in Figure 10b. The soundness of the stainless steel basket wire beneath the flaking nickel plate is attested to in both Figures 10b and 10c.

(10a) 27X

(10c) 250X
View of top of bend in wire appearing in Figure 10a, at a different level than that shown in Figure 10b. Etched in 20% HCl, 5% HNO_3 .

(10b) 250X
View of top of bend in wire appearing in Figure 10a. Separation of nickel layer from basket wire is evident.

4. The nickel-plated layer on stone dislodgers produced by one manufacturer acts as a source of cracks which contribute to the fracture of basket wires. It may be desirable to eliminate the nickel plating operation altogether. Stainless steel has an intrinsic corrosion resistance which makes it unnecessary to apply a nickel layer for corrosion resistance. Elimination of the nickel layer would also avoid the problem of flaking associated with the nickel layer, as shown in Figure 10.

5. Examination for flaking nickel layers on basket wires, and elsewhere, is desirable for stone dislodgers presently in use. This could be accomplished simply by looking at stone dislodgers after each use under a low-power binocular microscope. A magnification of 27X, as in Figure 10a, would be appropriate.
